CJ650B/5.2

SERVICE BULLETIN – CJ650B Trunk latch screw

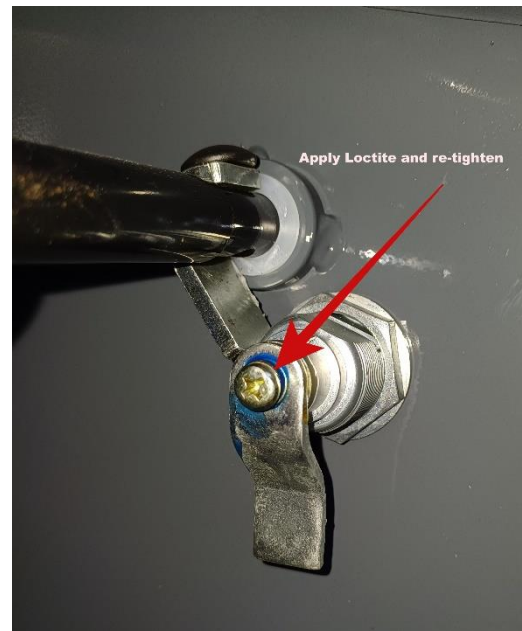
It has been noted that on several new units received by Dealers that the rear trunk lock screw has not been fully tightened during the factory production process. This can lead to the lock screw vibrating off during operation which allows the lock barrel to fall out. The following process is now to be carried out as part of the dealer pre-delivery set-up.

- 1) Remove the lock latch screw making sure that the lock is prevented from falling out by applying inwards pressure to the lock barrel (press the lock barrel inwards from outside the sidecar tub).
- 2) Remove screw taking note of the latch orientation.
- 3) Apply a small amount of Loctite (Blue) to the screw and retighten screw.
